New York State
Department of Correctional Services
Elmira Escape Report

March 19, 2004

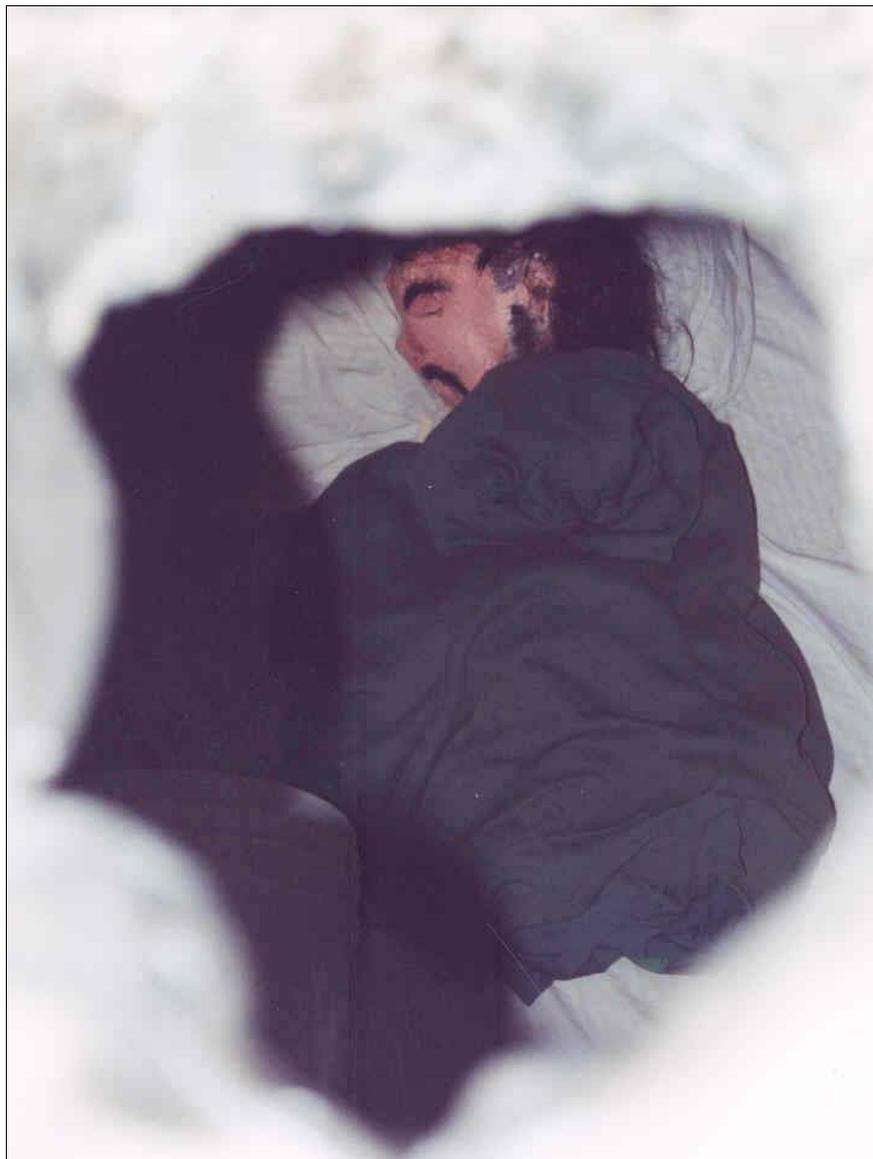
View from attic looking down through the approximately 9x12-inch hole dug through ceiling of cell block to the dummy left on the top bunk in cell F-7-2.

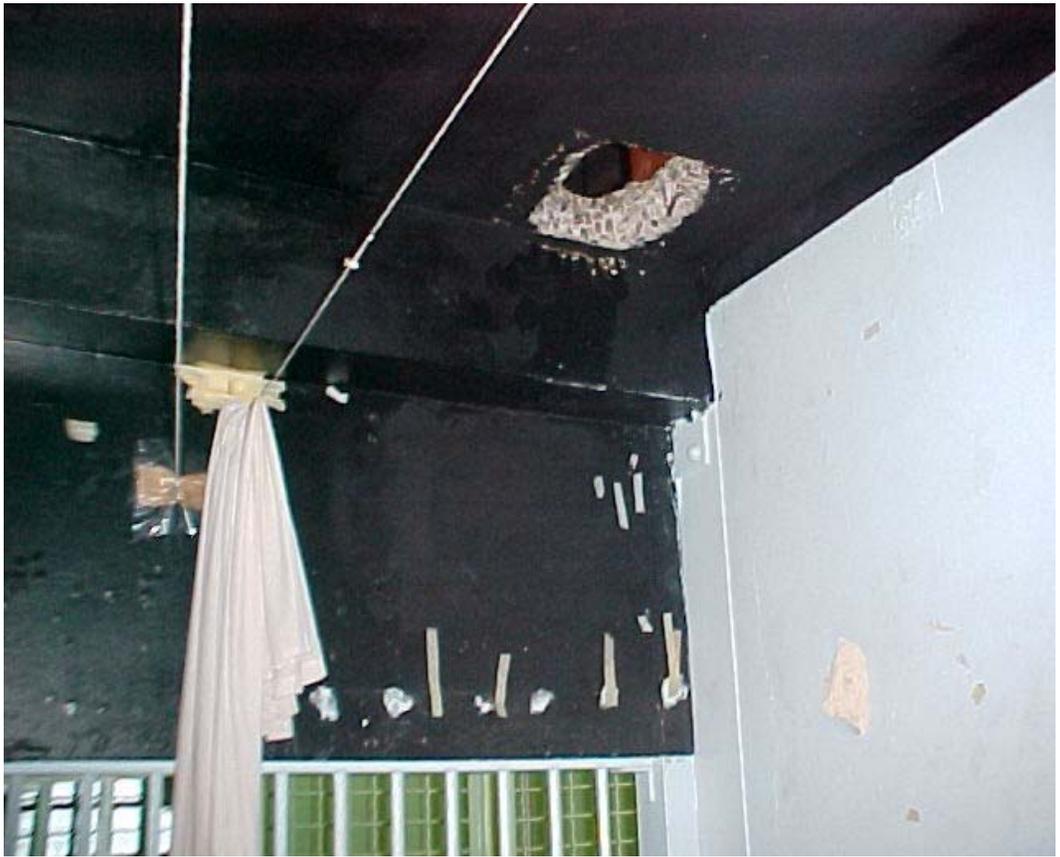
The location in which they chose to dig the hole is at the front of the cell in the right corner, when in the cell facing the gallery. Across the top front of the cell is a 36-inch deep panel. It encloses the mechanism that allows the steel bars of the cell door to be opened by sliding it to the right over a stationary panel of steel bars. From outside the cell, that panel across the top front of the cell blocks any view from the gallery of the hole the inmates dug into the ceiling. To further obscure their scheme, they cover the cell front with towels.

Hole is visible in front right of ceiling. Tape above cell bars held towels covering them.

Based on facility cell standards, cell inspections and facility policies, there is no reason except complacency that no one observed and reported the compromised ceiling or the construction paper covering the hole.

At the time of the escape, Elmira had inadequate cell layout policies. Inmates were allowed to arrange items in their cell as they saw fit. This allowed inmates to move their bunks tight against the cell bars and obstruct visibility into the cell. Appropriate cell layout policies are now in place and being enforced.

The hanging of towels, taped on the wall above the bars and hung down obstructing visibility was in violation of the Department's Standards of Inmate Behavior. Officers did not effect the removal of the towels and did not discipline the inmates for failing to comply. There is no evidence that Vail and Morgan had ever been disciplined for that offense. The towels did limit sight, contributing to the employee not being able to detect the dummies in the beds. The morning of the escape still found towels taped over the bars of cell F-7-2 as well as a towel hanging from a clothesline blocking sight lines from the gallery.

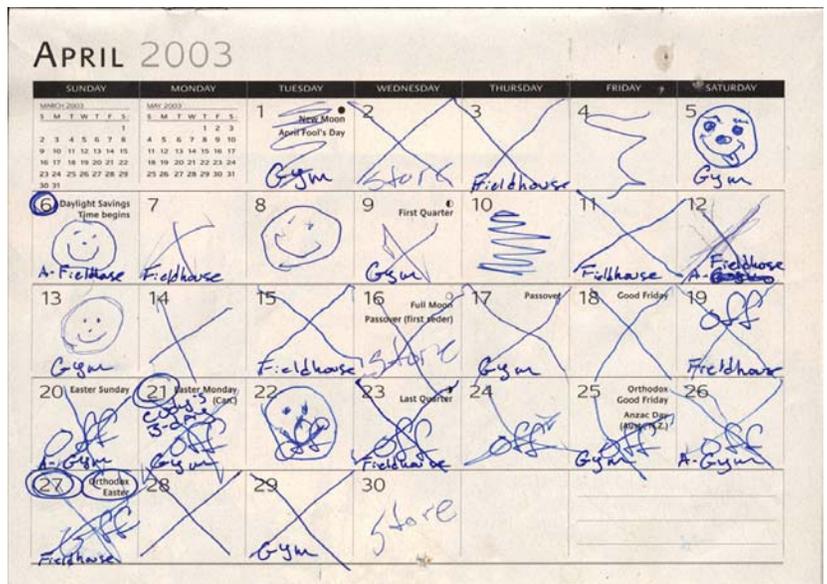
The inmates devise their own code to track their progress, almost in diary form, on a calendar found in their cell after the escape. In explaining their markings later to an investigator, they say dates where digging occurs are represented by an “X” – the first being March 7. “Smiley faces” (☺) represent days when much progress is made. “Squiggly lines” (such as on April 1st, in the calendar at right) signify days when no digging was done.

Calendar used by inmates to record their progress.

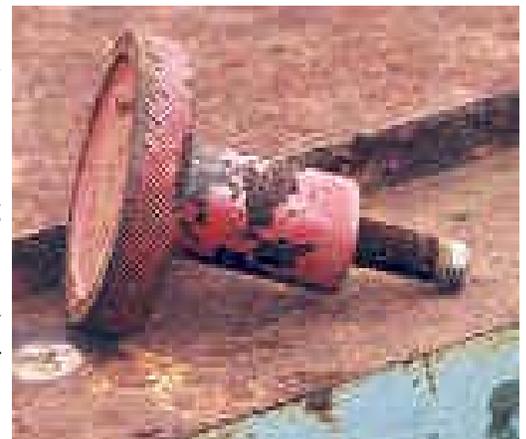
Instructor Silvers confirms that Vail is assigned one day to dismantle a Yates American Jointer Planer as part of his carpentry shop job. This surplus equipment is to be removed from the shop. The planer guide (shown below) is T-shaped: a flat circular disc three inches in diameter with a three-inch shaft protruding from the center. Vail hides the planer guide in the carpentry shop.

Planer guide used in escape preparations.

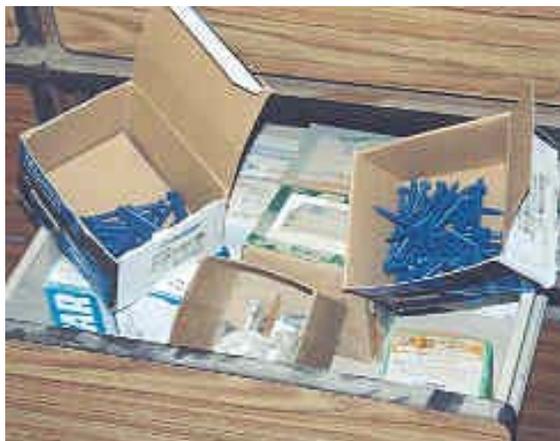
Vail had already hidden four, 4-5-inch sections of blade from an industrial band saw in a piece of plastic pipe in the carpentry shop. Vail uses the carpentry shop's Dremel tool to taper the band saw blades' cutting edges because he knows that will make it easier to saw through the rebar. He hides the blades in a tobacco pouch that he then glues shut. He knows that will allow him to smuggle them from the shop to his cell in packaging that will appear unopened to prison staff.

Unsecured screws as found in the carpentry shop.

Failure to follow the tool control directive on disposition of tools also contributed to Vail's acquiring the sledgehammer head. While investigation confirmed it had belonged to Shop #6, it did not appear on any shop inventories. There were no appropriate storage and distribution procedures in place to account for sheet rock screws, nails or concrete screws.

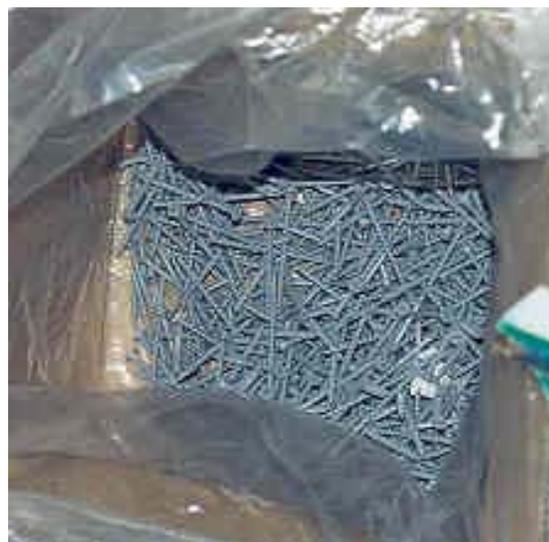
But, before leaving the shop, Vail secretes a taped bundle of roughly 25 sheet rock screws into each of the four hollow legs of the chair. Neither Vail nor the chair is searched as he returns to his cell block, where officers allow him to take the chair into his cell based upon Silvers' phone call.

Once the chair is in the cell, the inmates now have approximately 100 more sheetrock screws with which to dig – and the hollow legs of an approved chair in which to hide them.

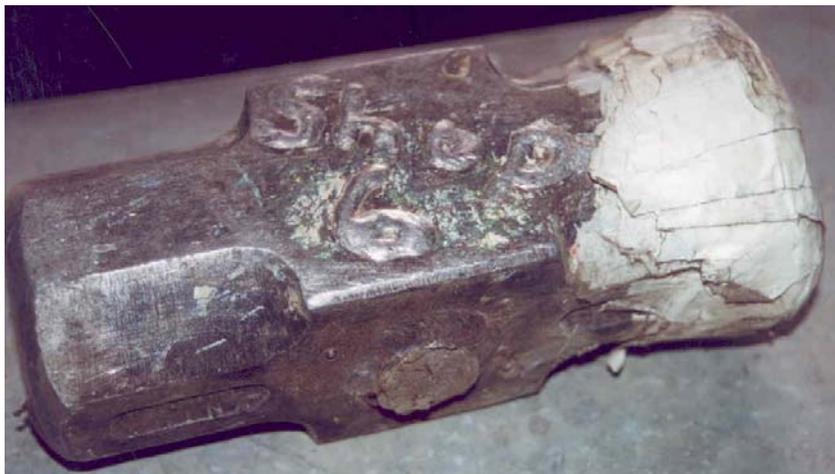
Sledgehammer head stamped "shop 6" with end taped to muffle hammering sounds.

"Shop 6" was a carpentry/maintenance shop in Building 6 that closed in the mid-1980s. It was packed up and moved to Building 4 to become the vocational carpentry shop now taught by Silvers where Vail works. Silvers would later tell investigators that the sledgehammer head was openly observed around the current carpentry shop for the entire 17 years that he has been working there. It was, he added, often used as a door-stop. When questioned after the escape about the current location of the sledgehammer head, instructor Silvers stated, "I thought it was thrown out."

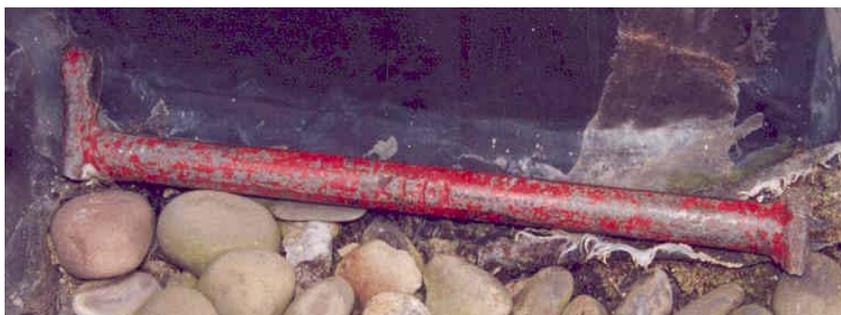
Vail removes a 14-inch stabilizer bar from a table saw in the carpentry shop, tapes it to his leg and brings it back to the cell block during a non-scheduled movement, thereby again avoiding a search and/or a metal detector. He later tells investigators that his plan is to have the bar available in case it is needed for any reason in the cell block attic during the final stage of the escape.

14-inch stabilizer bar taken from a table saw in the carpentry shop.

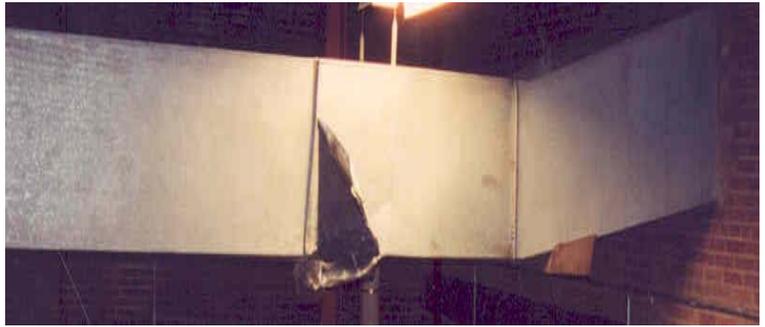
Vail opened this 30-by-24-inch steel duct in the attic some 10 feet from the exterior wall shown at right.

Vail then uses one of the self-tapping concrete screws to break the seam of the galvanized steel duct work. He then pries the duct work open with his bare hands, enlarging the hole enough to accommodate either inmate. Vail leans down and whispers through the hole, asking Morgan if he can hear him moving about and working in the attic; Morgan replies in the negative.

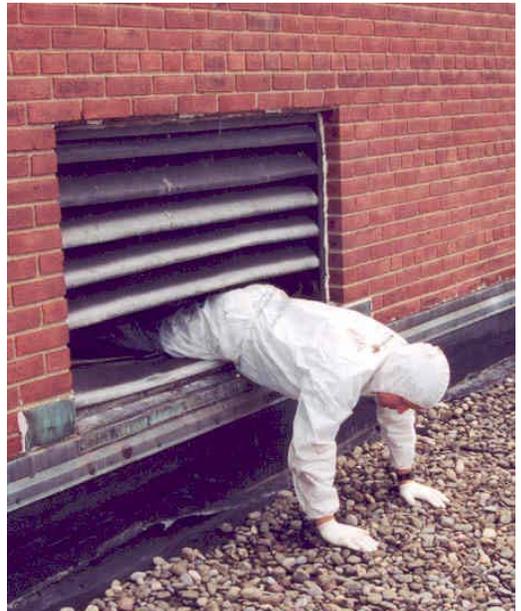
Vail brings up into the attic with him most of the items used to dig the hole in the ceiling. He explores the attic area, crossing the 24 feet from the cell ceiling hole to the ventilation duct work which vents to the F-Block roof.

Employee shows how inmates say they exited.

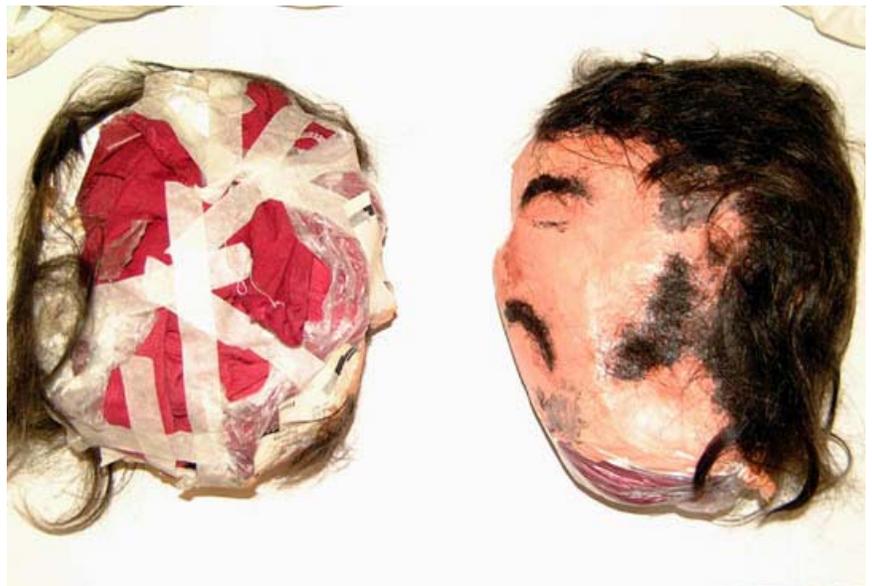
Back and front of dummy heads fashioned by inmates.

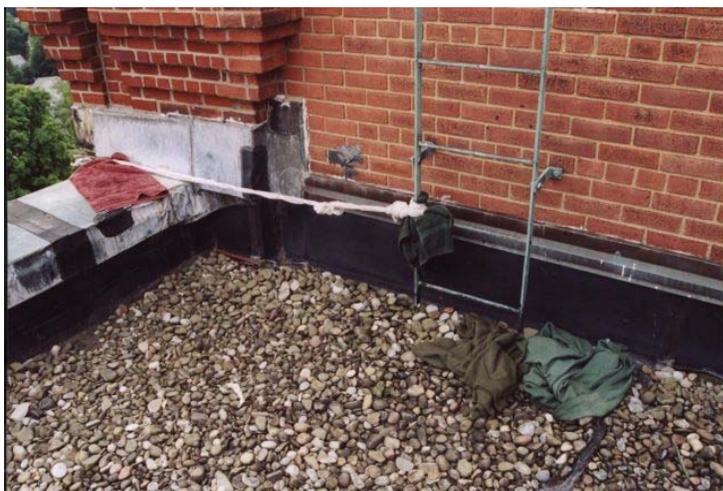
Rope tied to this ladder was dropped down front of facility.

The inmates creep the 36 feet east to a steel ladder located six feet from the edge of the roof at the front of the prison. The permanently-affixed ladder rises five feet to a higher roof. A turret jutting eight feet out from the prison wall blocks CO Richard Mustico in Tower Post 1 from seeing them. The inmates secure one end of the length of sheets to the base of the ladder and feed the other end over the edge of F-Block where the wall meets the turret.

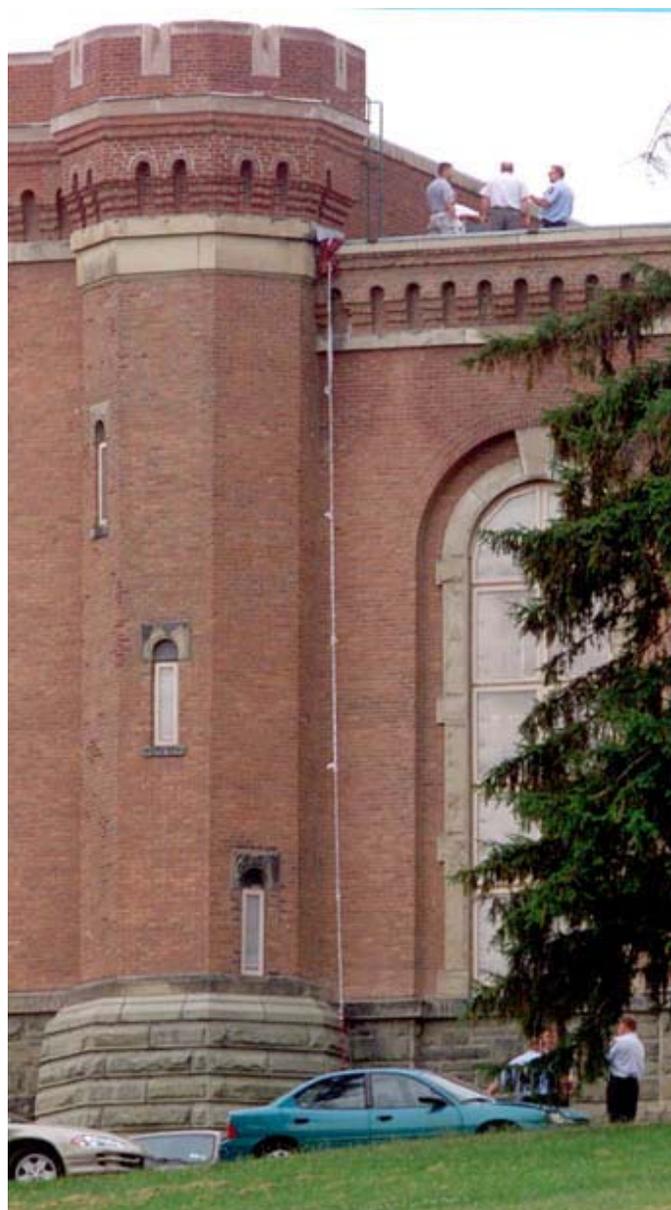
Morgan, still inside the duct work, passes the sheet rope and stabilizer bar out to Vail, then exits the louvred vent to join Vail on the roof.

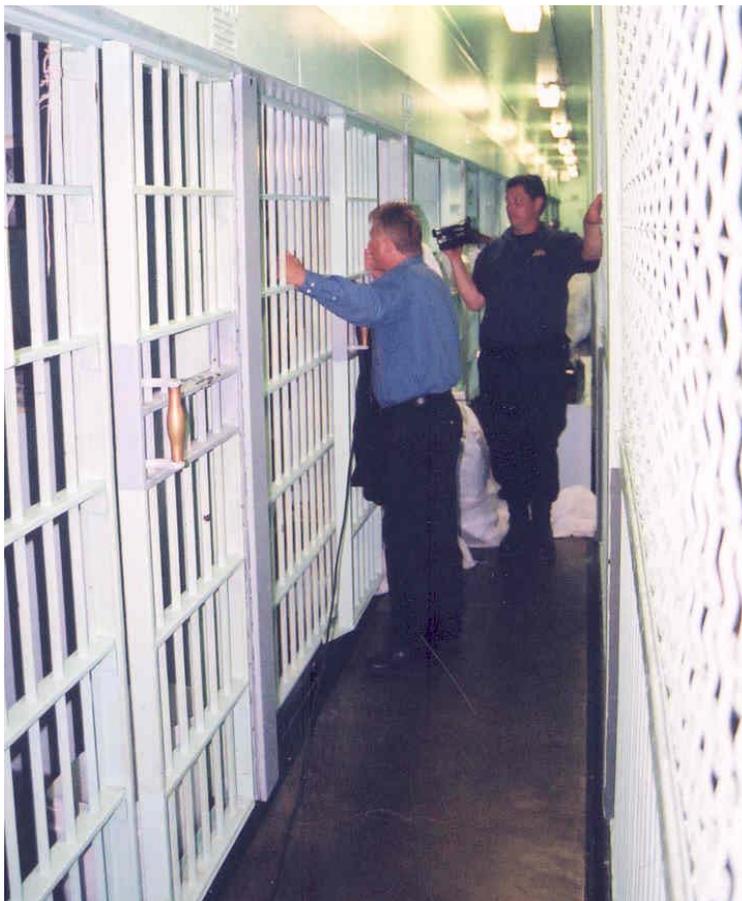
Staff examine cell after the escape.

The cell search logbook indicates Vail and Morgan's cell was searched three times after the hole in the ceiling was alleged to have been started and covered with a piece of construction paper painted black. Upon reviewing the cell search forms, there was no contraband recovered during any of these cell searches, nor any damage reported to the ceiling of the cell.

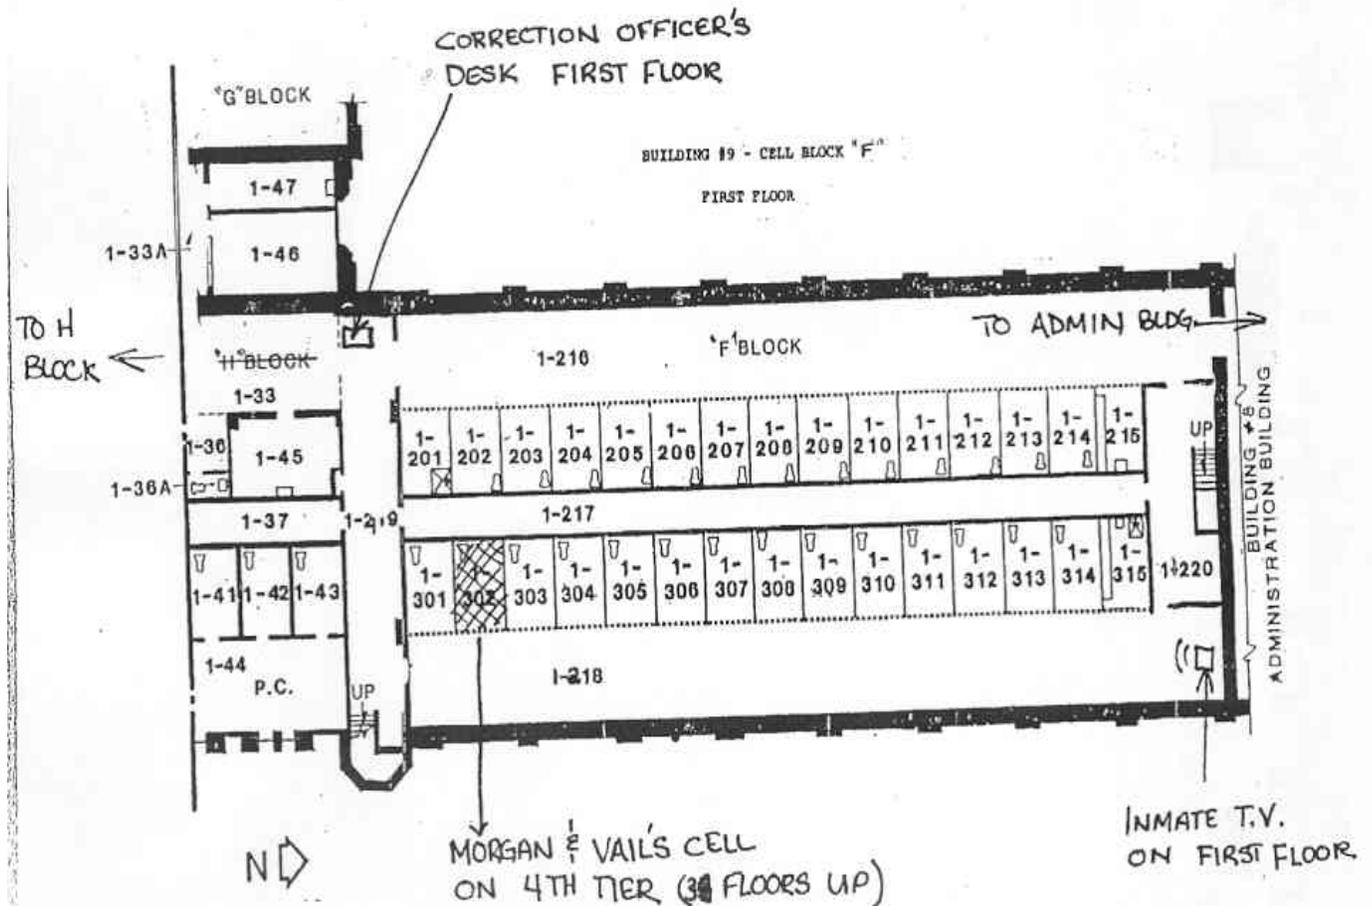
Diagram shows relative location of the inmates' cell, officer's station and gallery television set.

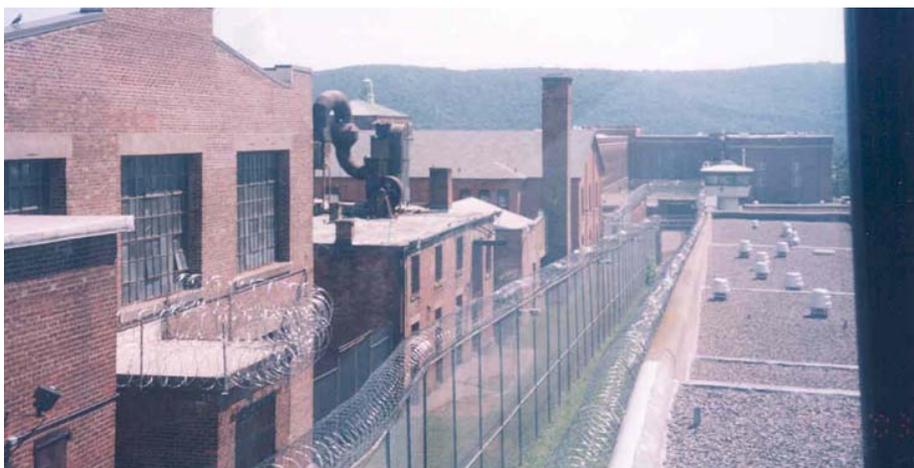
Tower Post 3 is an unstaffed post located at the southwest corner in the back of the facility. There were reports during the escape pursuit that an officer staffing Tower Post 3 would have been able to see the inmates on the roof of F-Block. But as the picture at right makes clear, Tower Post 3 has absolutely no line of sight to F-Block.

This photo was taken from Tower Post 3. In the right far background is H-Block. To its left, and totally obscured by Shop 1 Building behind the smokestack and then G-Block, is F-Block. Thus, Tower Post 3 has no view of F-Block.

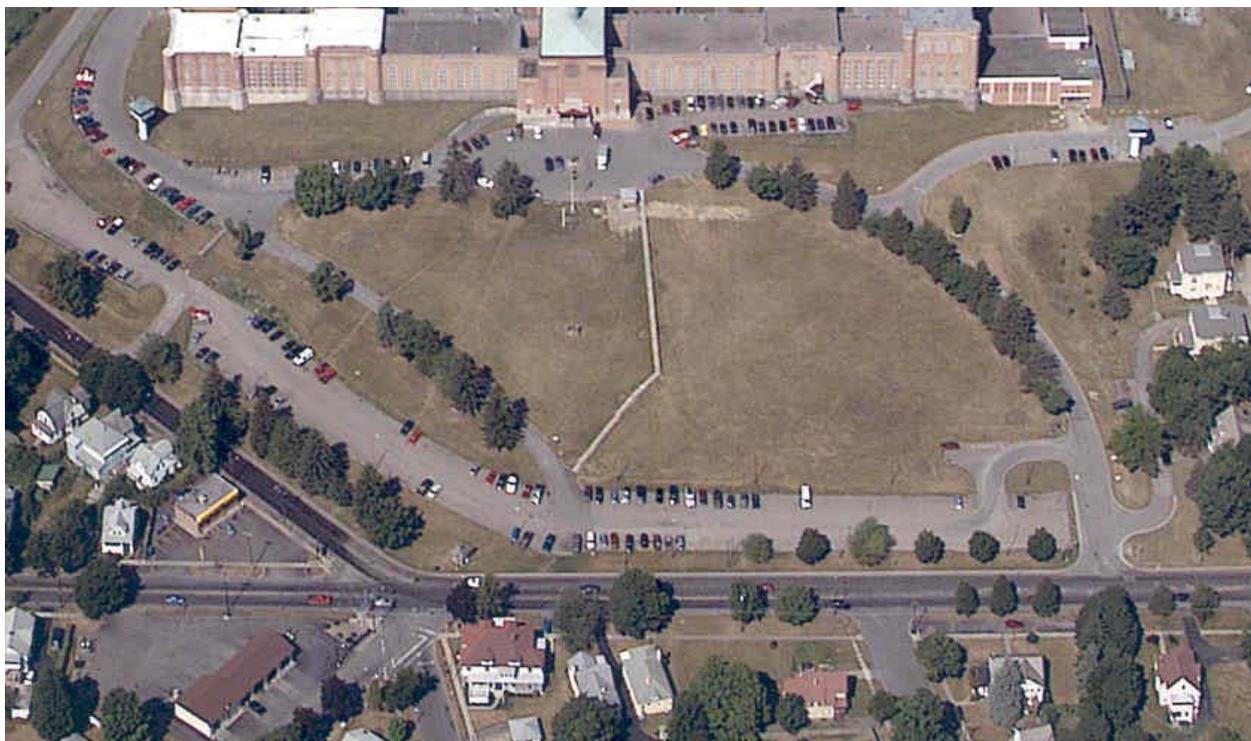
Tower Post 1 is the detached tower located to the front left of Elmira prison, with detached Tower Post 7 directly across on the right side of this photo. F-Block is located to the immediate left of the facility entrance. The inmates came down the front of the prison to the left of the main entrance, just to the right of the first turret. Post 9 is located in the small building at the front edge of the upper parking lot, to the left of the walkway that angles down the hill to the lower parking lot. This view of the facility is intentionally limited, because the Department does not, for security reasons, circulate aerial photographs detailing the entire layout of state prisons.
